# APPLICATION NOTE

E-Mail: [cis.support@clipsal.com.au](mailto:cis.support@clipsal.com.au)[clipsal.com](http://clipsal.com)**Title : C-Bus Network Bridges - 'looping back'****Category : C-Bus Application**

Reference No: 11-002-1

Issue Date: 20 July 2011

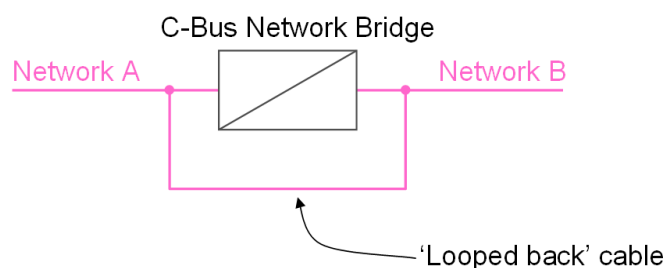
It is possible for a C-Bus system to be installed with Network Bridges 'looped back' onto the same C-Bus network, as shown in the diagram below. This could compromise or damage a C-Bus installation.

Diagram showing a C-Bus Network Bridge with the far side of the unit looped back onto the near side network.

Although it is physically possible for a C-Bus system to be installed in this manner, it performs no useful C-Bus application purpose. It is considered bad installation practice as it can cause the following physical and communication issues on a C-Bus Network.

- The C-Bus network current may exceed the recommended 2A maximum
- The combined C-Bus network cable length may exceed the recommended 1km maximum length
- The network burden & capacitance will be affected.

- C-Bus Network Bridge routing will be compromised, possibly resulting in units being incorrectly programmed via C-Bus Toolkit software
- Duplicate C-Bus unit addresses may appear on the combined network resulting in incorrect C-Bus system behaviour
- Incorrect C-Bus operation may occur as a result of problems caused with C-Bus Trigger Control messages, Date and Time messages, Security Application messages and Media Transport Control messages.

Clipsal Australia and Schneider Electric requires that C-Bus Network Bridges are not connected in this 'looped back' configuration.
